The Alaskan Way Viaduct & Seawall Replacement Project

09.06

A Retrofit is Not Enough

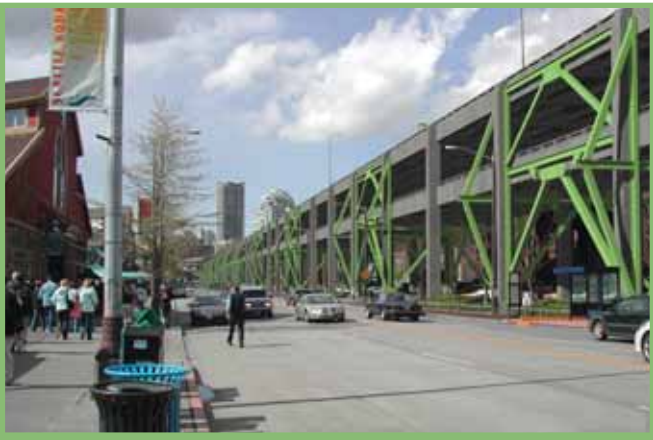
Streetscape rendering of the viaduct with the retrofit proposal.

- Installation of steel strengthening frames running crosswise and lengthwise at the middle columns and bays of each viaduct section. The viaduct is made up of independent sections approximately 220 feet long. The proposal evaluated did not include specific dimensions for these pieces of steel so T. Y. Lin International estimated the appropriate sizes.

- Wrapping of steel jackets around the base of some of the columns to provide additional strength to the structure. T. Y. Lin International believed these jackets would be required for all of the columns and so added them to the proposal.

- Placing of shock absorbers within the middle bay of the viaduct. Additional shock absorbers were shown between adjacent sections to prevent them from banging into each other during an earthquake. Because the evaluation looked at one section of the viaduct, these were not included. However, T. Y. Lin International concluded that these shock

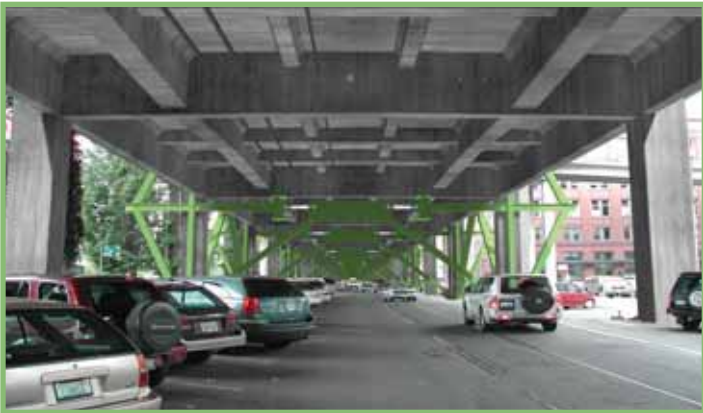
Rendering of retrofit proposal for area under the viaduct.

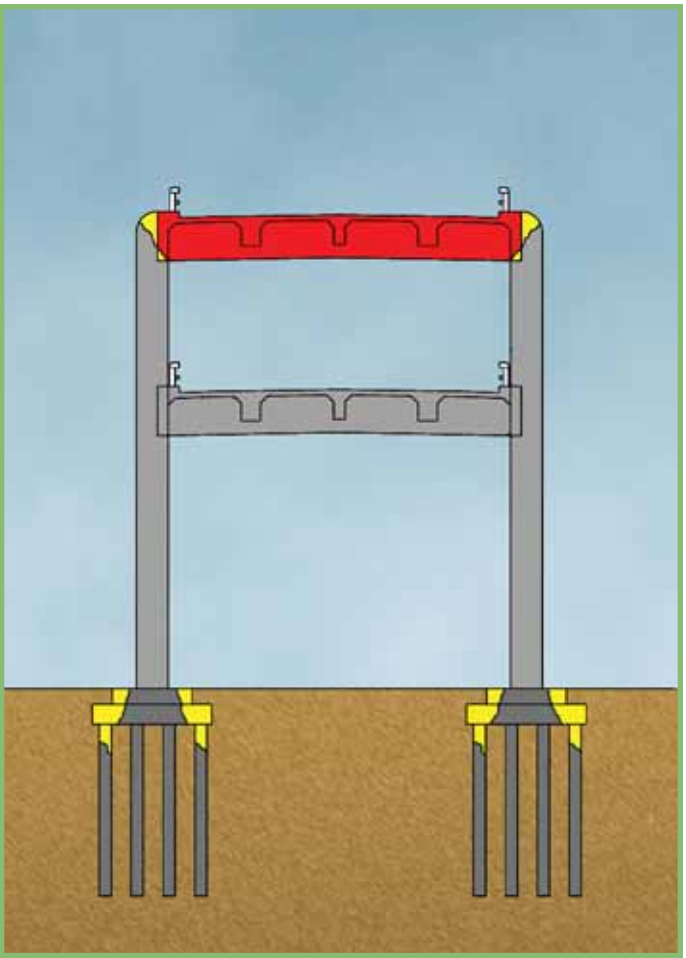
Shown in red is the expected damage for the design for 500-year earthquake.

For the very bad earthquake, the evaluation shows that the retrofitted viaduct will collapse, likely causing loss of life. The reasons for this collapse are:

- The footings of the viaduct would be subject to higher shear and flexural demands, and higher joint shears than for the bad earthquake. Severe damage of the footings is likely.
- The piles would be subject to higher compressive forces that cause severe damage to the footings.
- The columns will rock on the pilings, which they were not designed to do. This rocking may result in severe impacts to the adjacent viaduct sections. The columns are very brittle and the loads from the rocking plus the damage to the footings would likely cause the viaduct to collapse.
- Other parts of the viaduct will also be severely damaged and could fail. For example, the floorbeams will suffer from negative bending at the connection with the columns. The knee joints – some of which failed in the Nisqually earthquake – could also fail

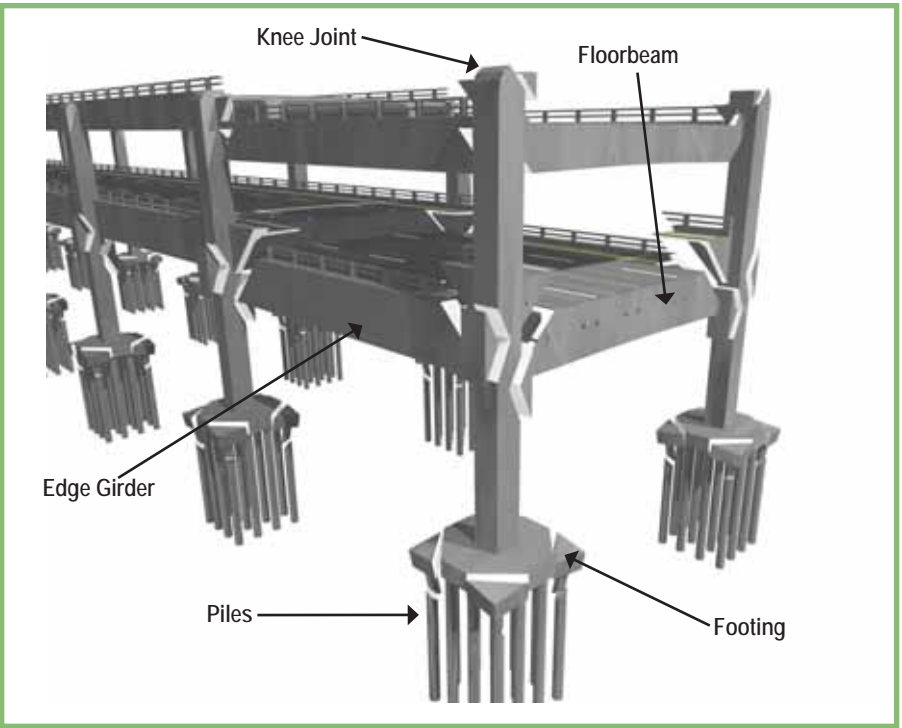
The viaduct has many weak points that could cause it to collapse in a very bad earthquake.
